Field measurements of Vibrations in a wooden floor

Delphine Bard and Juan Negreira Montero

Division of Acoustics, Lund university, Box 118, SE 221 000 Lund, Sweden, delphine.bard@construction.lth

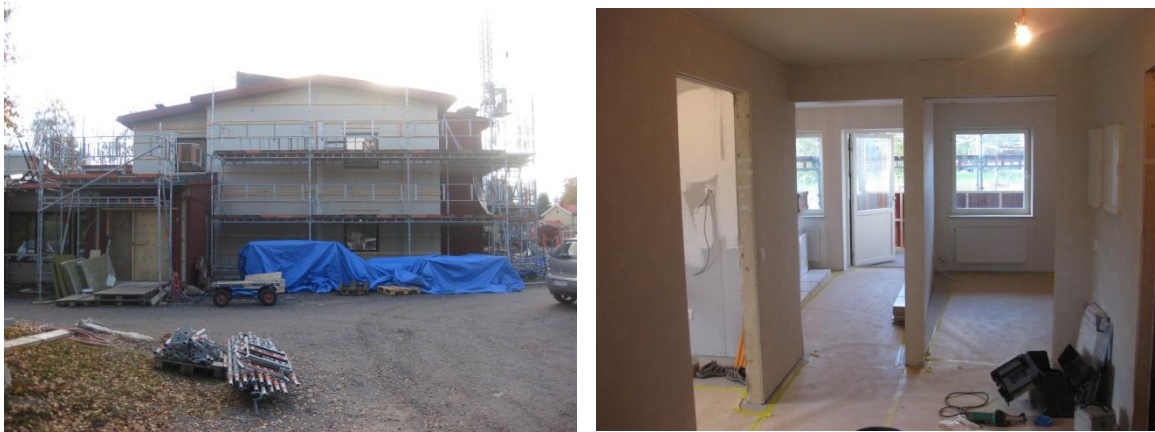
The work presented here takes place in Nordmaling, on the east coast south from Umeå. The figure 1 shows the measured building and the dwelling.

Figure 1: The building and measured dwelling.

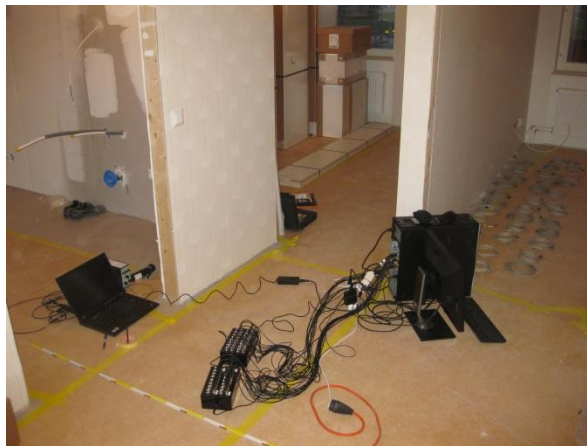
The investigated floors are situated in one of the apartments of the building, as shown in figure 2.

Figure 2: Measurement set-up on the floors.

Arrays of accelerometers were fixed tightly in place with screws on the floor that was investigated. The sensors were disposed along a line parallel to the walking direction,
